**UPFITTER INTEGRATION Bulletin 102.1**

SUBJECT: No Drill Zones MODEL YEARS: 2024 & Beyond AFFECTED MODELS: UD Model ONE & UU Model THREE INITIATION DATE: 08/29/2023 REVISION: 10/05/2023

**Description of Concern:** Mounting upfit equipment near NO DRILL/NO CUT zones for HIGH VOLTAGE Electrical safety.

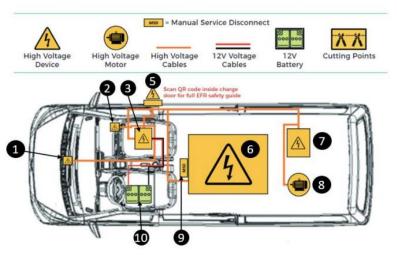
Solution: Mullen ONE - NO DRILL/NO CUT ELECTRICAL AREA

- 1. Positive Temperature Coefficient (PTC) Heater
- 2. Air Conditioning Compressor
- 3. 3-in-1 (On-Board Charger, DC-DC Converter, Low-Voltage Distribution box)
- 4. High Voltage Cables (Shown in orange)
- 5. Inlet Charging Port
- 6. High Voltage Battery
- 7. MCU Motor Controller Unit
- 8. High-Voltage Drive Motor
- 9. Manual Service Disconnect (MSD)
- 10. 12-Volt Battery

- 1) Maintain a minimum static clearance of 150mm / 3" between frame rail mounted HIGH VOLTAGE Batteries/Components/Wiring and Upfit Body/Equipment.
- 2) Do not alter or relocate HIGH VOLTAGE components from the OEM chassis location.
- 3) Do not mount Upfit Body/Equipment to the HIGH VOLTAGE Batteries/Components/Wiring.

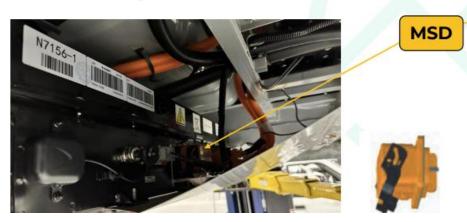
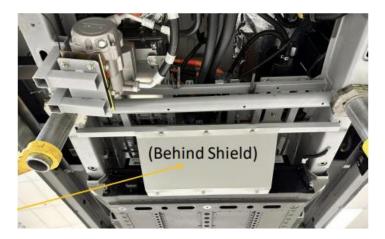
The Manual Service Disconnect ("MSD") Uses a two-stage release tab. When removed, this component provides a way to safely disconnect the high voltage battery from related components.

Removing the manual service disconnect (MSD) from the high-voltage battery does not dissipate voltage inside the battery, the battery pack remains live and dangerous.

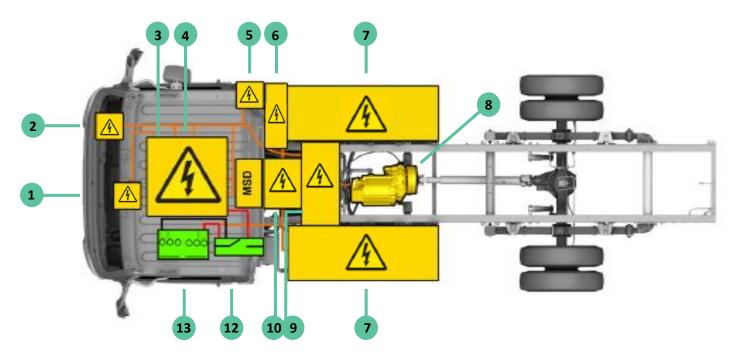
#### Mullen THREE - NO DRILL/NO CUT ELECTRICAL AREA

1. Positive Temperature Coefficient Heater (PTC)	<u></u>	7. High Voltage Battery (2 on each side)	A
2. Air Conditioning Compressor (AC)	4	8. High Voltage Drive Motor	
3. Electro-Hydraulic Power Steering Pump (not shown – located beneath 4-in-1)	<u></u>	9. On Board Charger (OBD)	4
4. Auxiliary Drive System (4-in-1)	4	10. Battery Disconnect Unit (BDU)	4
5. Inlet Charging Port		11. Manual Service Disconnect (MSD)	MSD
6. High Voltage Battery Heater	4	12. 12-Volt Manual Battery Disconnect Switch	
12-Volt (Negative) Cables	—	13. 12-Volt Battery	000 000
12-Volt (Positive) Cables	_	High Voltage Cables

- 4) Maintain a minimum static clearance of 150mm / 3" between frame rail mounted HIGH VOLTAGE Batteries/Components/Wiring and Upfit Body/Equipment.
- 5) Do not alter or relocate HIGH VOLTAGE components from the OEM chassis location.
- 6) Do not mount Upfit Body/Equipment to the HIGH VOLTAGE Batteries/Components/Wiring.

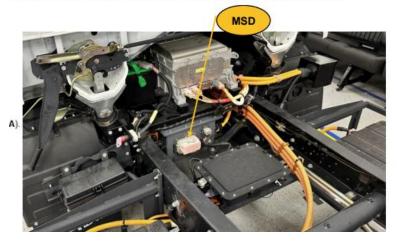
The Manual Service Disconnect ("MSD") Uses a two-stage release tab. When removed, this component provides a way to safely disconnect the high voltage battery from related components. Removing the manual service disconnect (MSD) from the high-voltage battery does not dissipate voltage inside the battery, the battery pack remains live and dangerous.
